# MASTER FIRE PLAN TASK FORCE

## STATION LOCATION SUBGROUP REPORT

**Date:** December 2008  
**Subject:** Fire Station Locations  
**Subgroup Name:** Station Location Subgroup

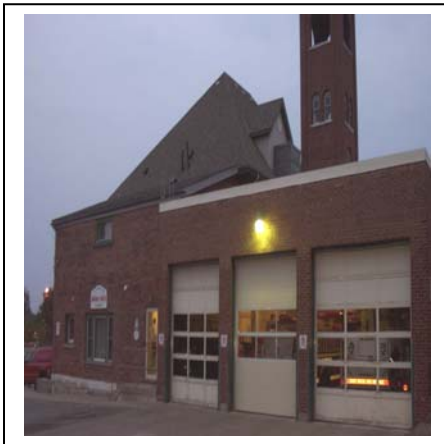
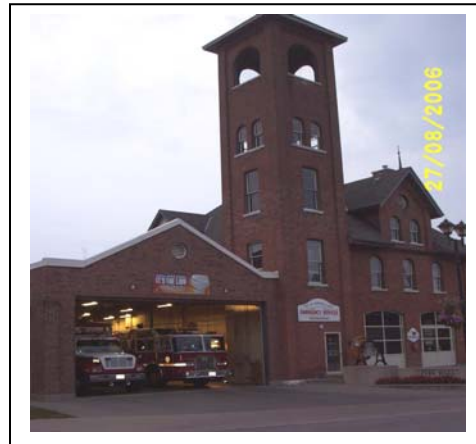
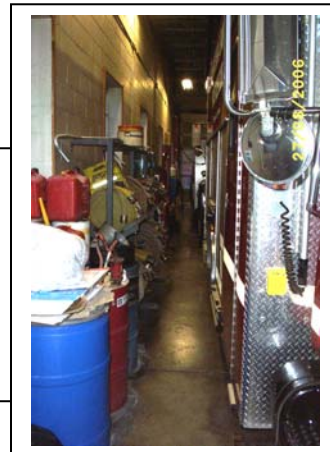
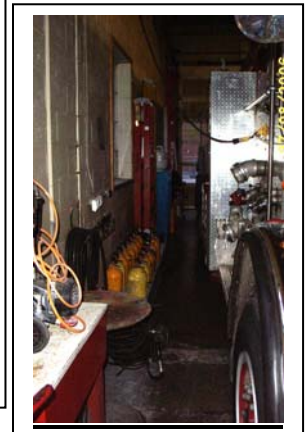
**STATION No. 1:** Lindsay – 9 Cambridge Street North, Lindsay

**RATING:** D-C

Too small for the number of administration offices in a combined response station.

That immediate consideration be given to relocating the Administrative offices.

That future consideration should be given to relocating the suppression station outside the downtown area.

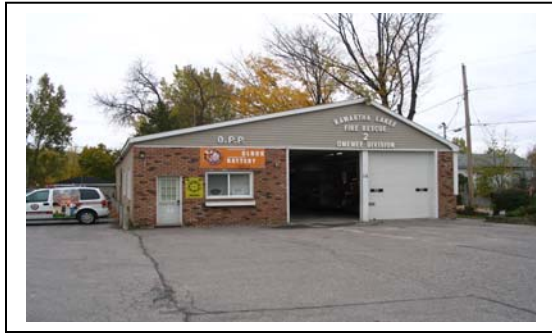
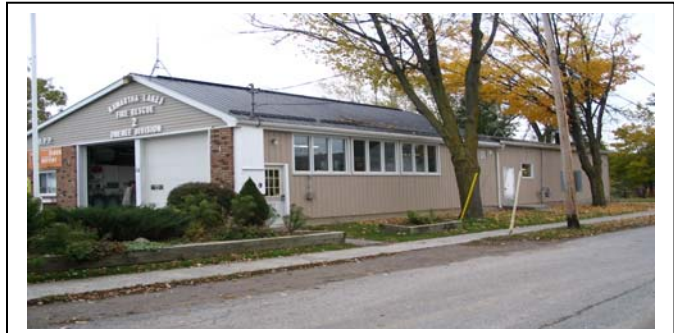
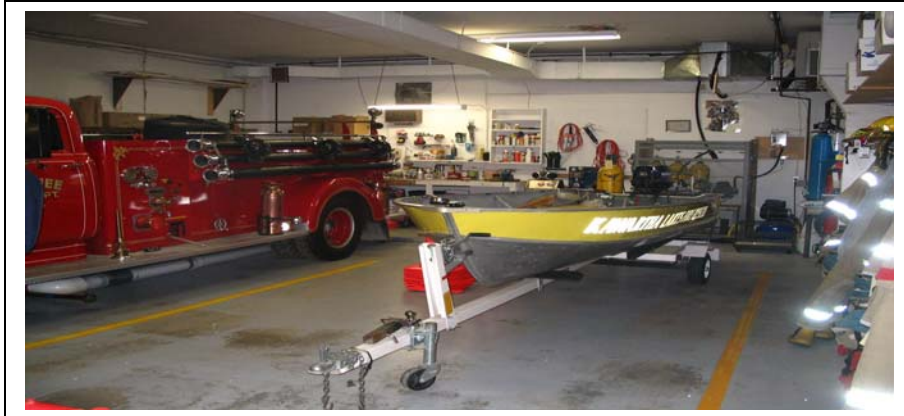
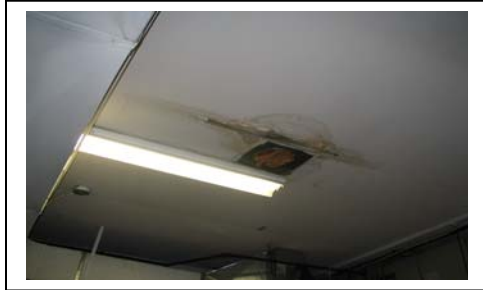
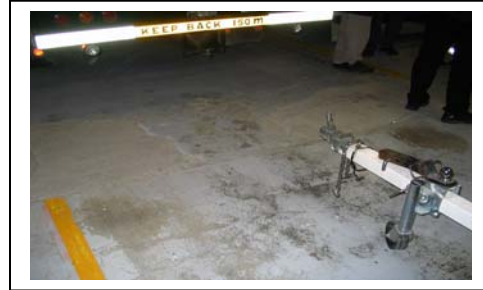
**Station No. 2: Omemee**

**RATING: C**

Concrete floor in truck bays is cracked, broken and uneven; water runs to the back of the hall, not to the drain. Electrical wiring needs to be upgraded; aged wiring overloading circuits. Exterior doors are old and do not seal out the cold. Wood paneling in truck bays serves as poor insulation; fire hazard (replace with drywall). Drywall needs repairs and repainting (caused by leaks in old ceiling). Floor in laundry room needs to be resurfaced (uneven and cracked). Driveway in front of doors is uneven and water lays in front; turns to ice in winter. Upgrades included new windows in 2003, new steel roof in 2004 and an electric door opener.

That consideration be given to relocating Station 2 in concert with the community's future downtown business development plans.

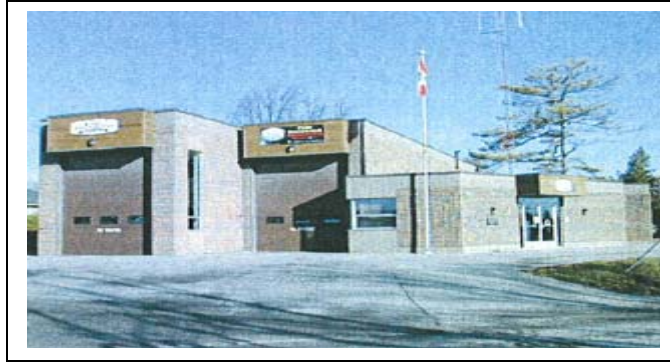
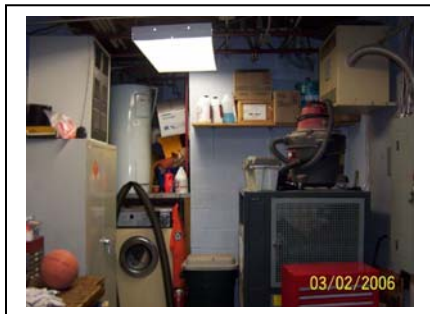
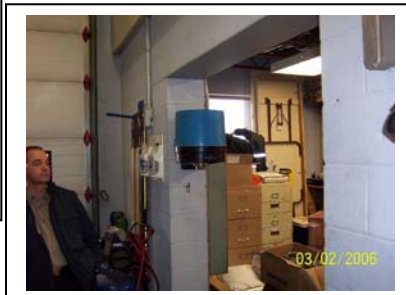
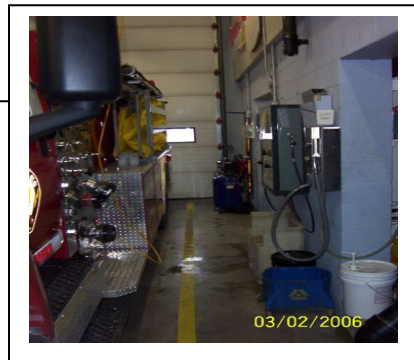
**Station 3: Bobcaygeon – 1 Duke Street, Bobcaygeon**

**RATING: C-B**

Station is short on storage space, office space, training area, kitchen area, dayroom for downtime, locker room for males and females.

The original plans for this building included a provision for a second storey for future expansion. This should be investigated along with providing additional floor space for ambulance parking. This would allow fire prevention vehicles to be parked inside for security purposes.

That a second storey and ambulance bay be added to the station. That the parking area for ambulances be increased.

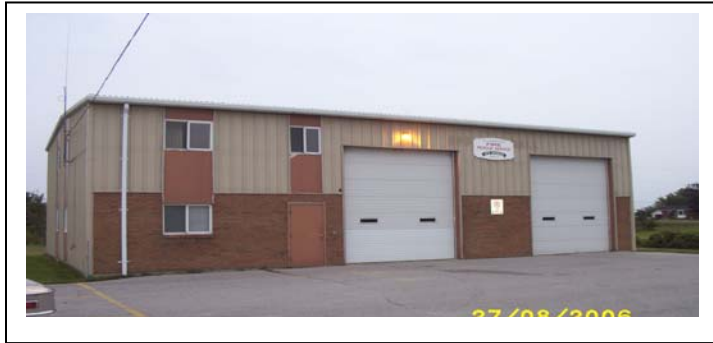
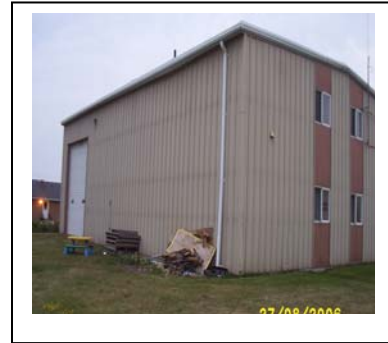
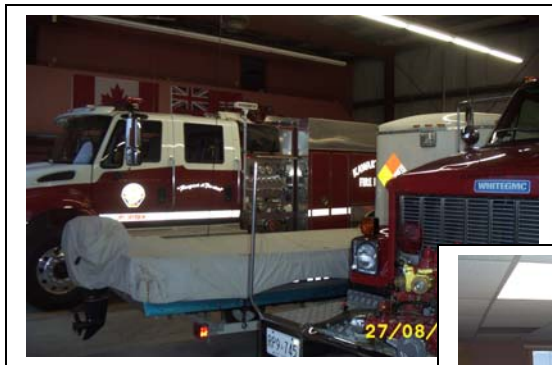
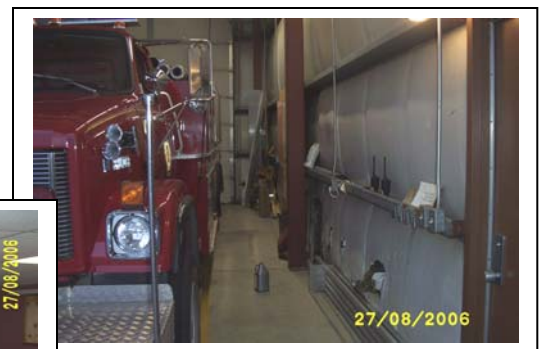
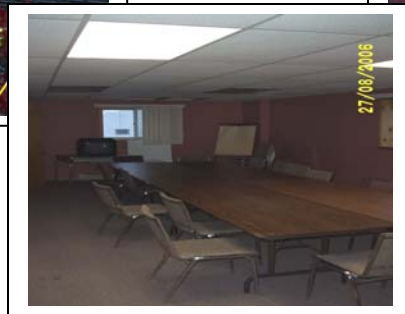
**Station 4: Ops – N/S Highway 7, Lindsay**

**DESCRIPTION:** Station has been closed for occupancy since 2007.

**RATING: D**

Roof repairs/insulation replacement. Will require extension to accommodate bronto lift.

That immediate steps be taken to correct roofing/insulation problems.

That prior to renovation to accommodate bronto lift, consideration be given to use this station as a specialized mechanics bay for fire trucks.

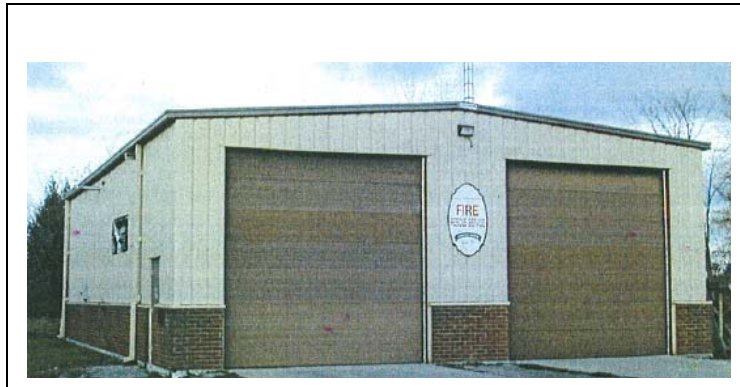
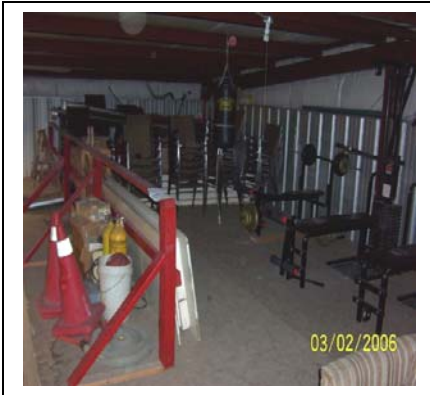
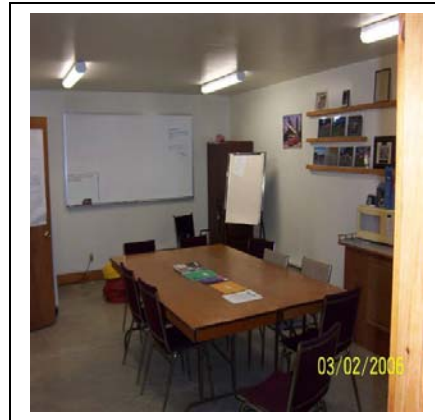
**Station 5: Dunsford – Pt. Lt 5,C3, Verulam**

**DESCRIPTION:** The Dunsford station was constructed as a substation to the Bobcaygeon fire service. The station was built to handle two trucks but currently houses three units. Some minor building repairs are needed to maintain the condition of the hall. Parking lot was high-floated and shows signs of wear and tear.

Station is not in bad shape and has good location. It was built as a substation to Bobcaygeon and as such is probably adequate to handle the call volume for the area. Some minor building repairs are needed to maintain the condition of the building, but are due to normal wear and tear. The parking lot was surfaced with high-float treatment and present call volume is enough to show damage; asphalt should be considered.

That upon Master Fire Plan review in five years, consideration be given to reviewing the advantages/disadvantages of merging this station and the Emily station.

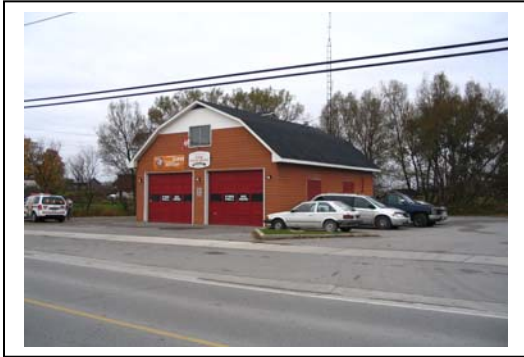
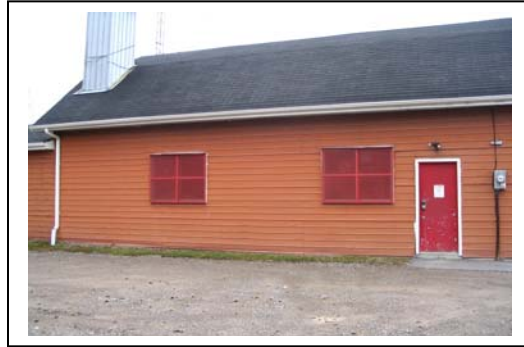
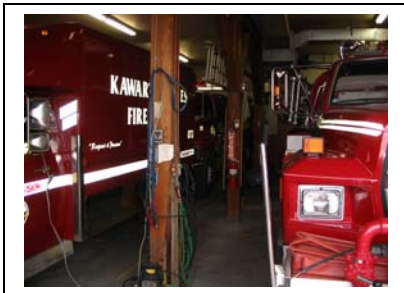
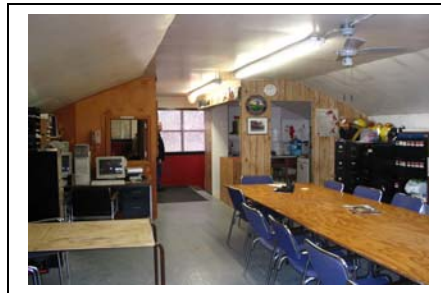
**Station 7: Bethany – Highway 7A, Bethany**

This hall is very poorly located on a small property situated near a creek, which compromises expansion options. The structure is old and provides limited parking. Upgrades and additions have been made, however the site is not large enough to accommodate the efficient operation of a fire station.

Hall is very small; trucks do not fit in hall properly; no clearance to walk around vehicles. There is no parking around hall and no room for expansion.

That the hall be relocated to Ski Hill Road, approximately 1 km. from the intersection and current site. Property is city-owned and is part of a subdivision agreement that has this property earmarked for a fire station.

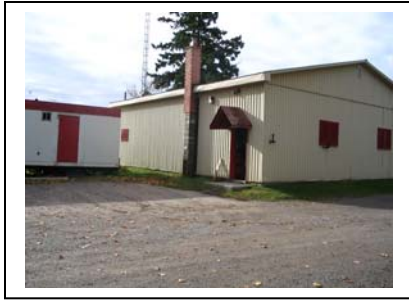
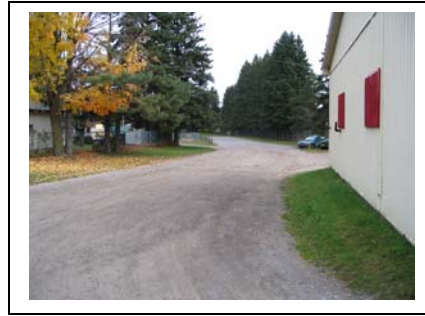
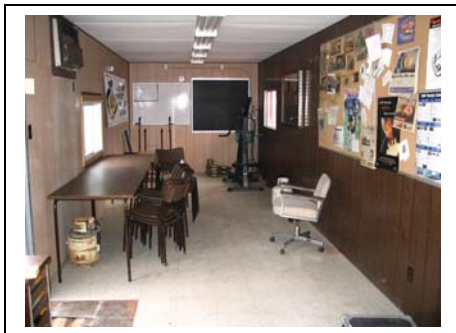
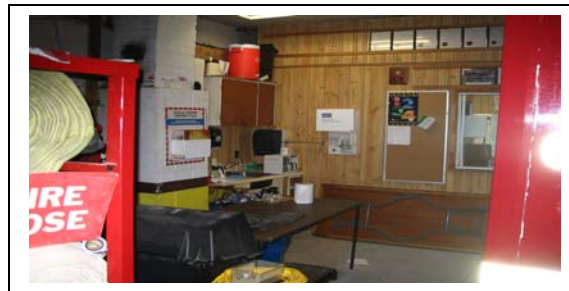
**Station 8: Pontypool – LII,C3, Pontypool**

**DESCRIPTION:** This hall is constructed from four garages/sections and is poorly located near a public park. The structure is old; training room is located in an attached, unheated trailer; there is minimal room for firefighters.

**RATING: D**

Very small hall that requires considerable work. There is no heat in the training trailer. Proximity to public park heightens risk to public and to firefighters. Front drive is in need of replacement.

That this hall be relocated closer to Highway 35, ie., near the training grounds/reservoir on John Street. New fire hall would provide better access for responses without bottle-necking hall.

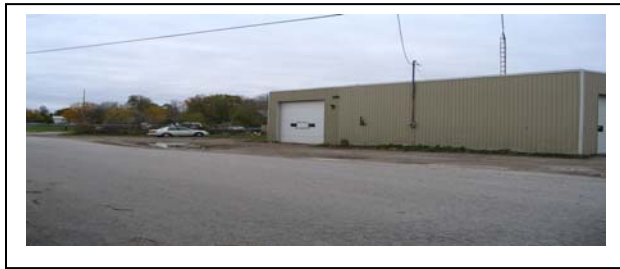
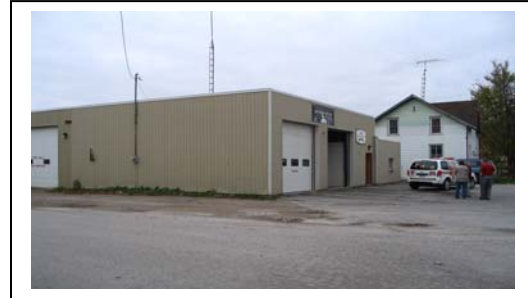
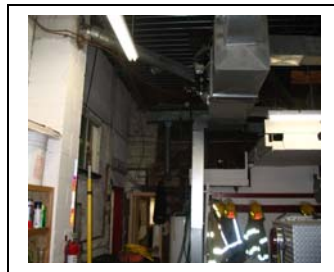
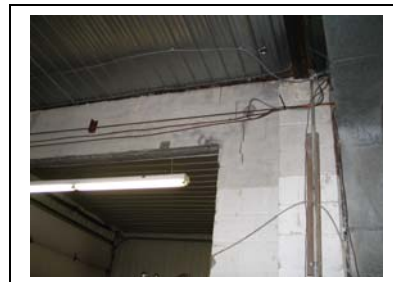
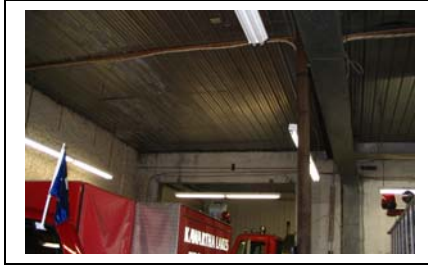
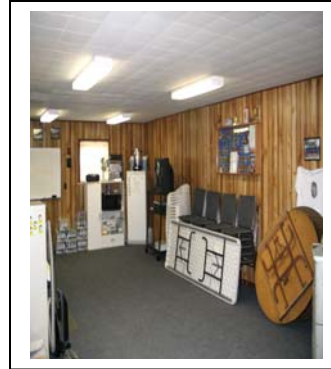
**Station 10: Little Britain, 1050 Little Britain Road, Little Britain**

**DESCRIPTION:** Station is located in a flood plain. Station is old and poorly insulated; size is restrictive for newer fire vehicles.

**RATING: D**

Structural Concerns: Hall is not properly insulated; in winter months, oil furnace runs 24 hours a day 7 days a week. Oil tank supplying furnace has been in service exceeding 25 years. A load-bearing wall between truck bays is being held together with one 10-foot piece of threaded rod. Areas of load-bearing walls are severely cracked between blocks. Floor drains in truck bays are a trip hazard. Slope of floor allows water to pool in areas and creates freezing conditions in winter months. Plumbing leaks (taps, toilets, lines). Water is not drinkable. Hot water tank is rusting and paint is bubbling.

Exhaust vents in washrooms are not installed correctly. GFI circuits are required in washrooms and should be installed in truck bays. Wiring is exposed throughout the station; wires are not properly secured on walls. Junction boxes and receptacles are not properly secured on walls. Excess wiring leads to nowhere (wires are merited and exposed to moisture). Outside of east bay door is dirt-base, thus creates large potholes and builds large amounts of ice in winter months. Station is located in a flood plain.

Relocate station closer to highest population base; consider addition of ambulance bay. Construct a functional fire station capable of housing a pumper-tanker and a skid mount apparatus in the area of Ramsey Road and Eldon Road.

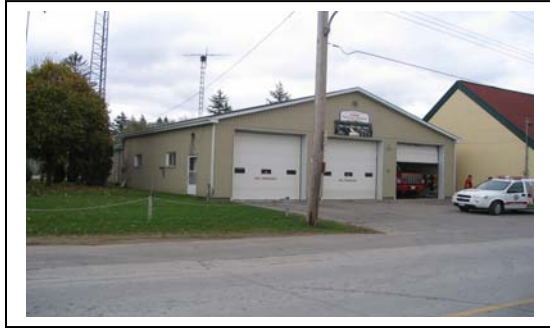
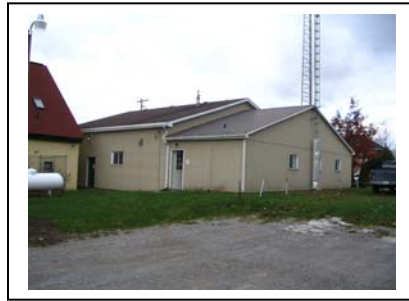
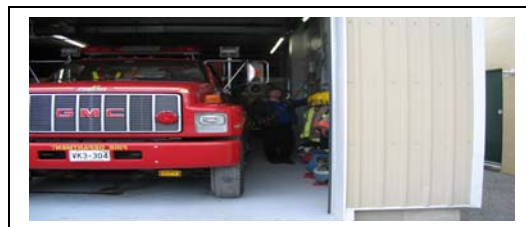
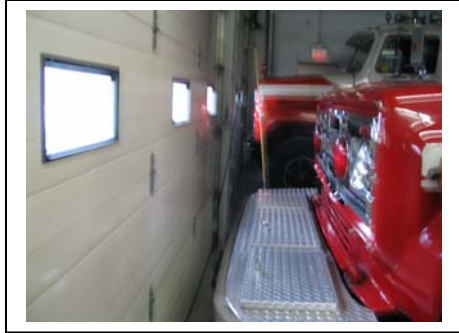
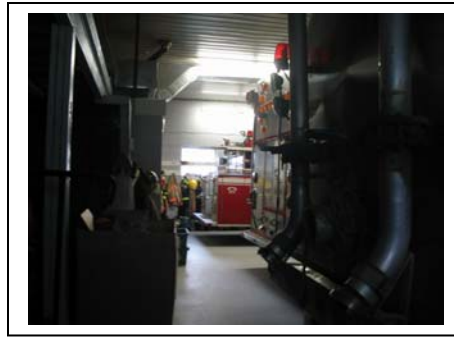
**Station 11: Oakwood, Eldon Road, Oakwood**

**DESCRIPTION:** Station is ideally located near Highway #7, however is small and will cause problems with newer, larger fire equipment accommodation. There is considerable municipal property surrounding the hall, thus future expansion and/or renovation should not be problematic.

Small hall; cramped for vehicles and equipment. Drain at front of station needs to be fixed. All windows need to be replaced. Door needs to open out. Hall needs to be painted.

That further investigation be undertaken to look at options for expanding the fire hall to accommodate appropriate-size training room and storage.

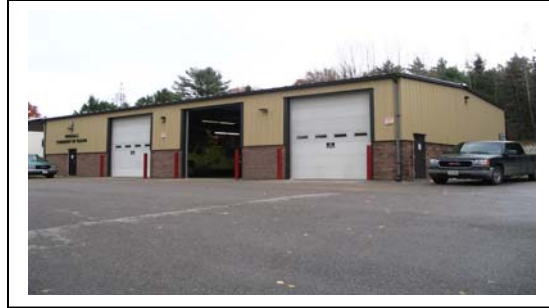
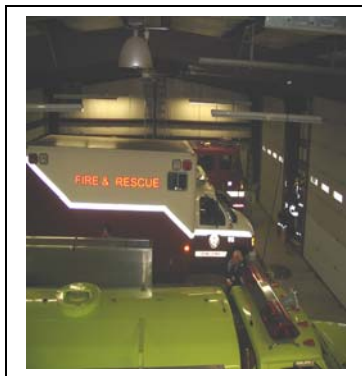
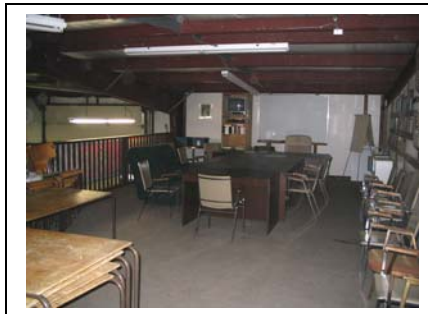
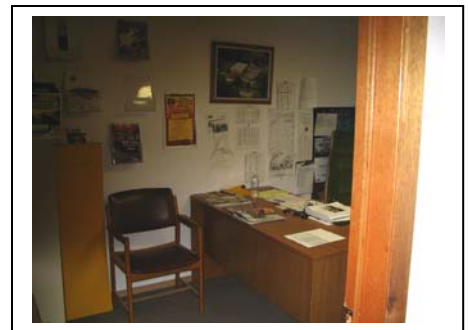
**Station 15: Kirkfield – Munroe Street**

Few problems identified. Two floor drains, one at each end of hall, would prevent truck runoff from getting into the walls. Some minor repairs needed to walls at each end as result of previous runoff. Automatic garage door openers would prove efficient. Water not fit to drink; air inductions system would correct problem.

Immediate attention should be directed to water system.

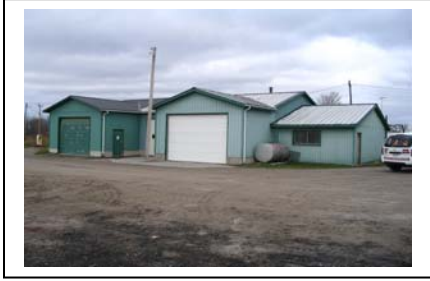
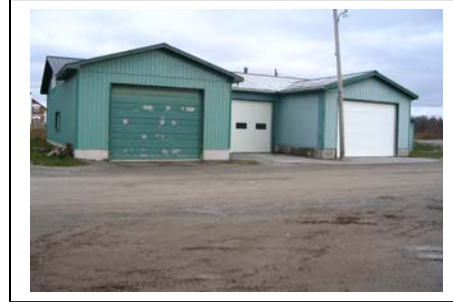
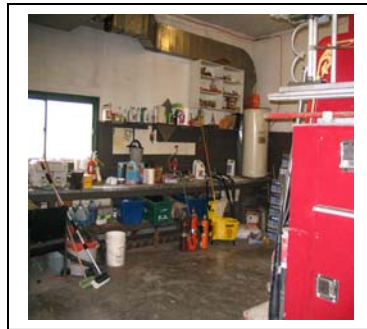
**Station 16: Carden – Lake Dalrymple Road**

Small hall; poorly laid out. Adequate for low call volume. New windows are required. Larger paved area desirable. New furnace required.

Low call volume for this station warrants further investigation when Fire Master Plan is reviewed in five years.

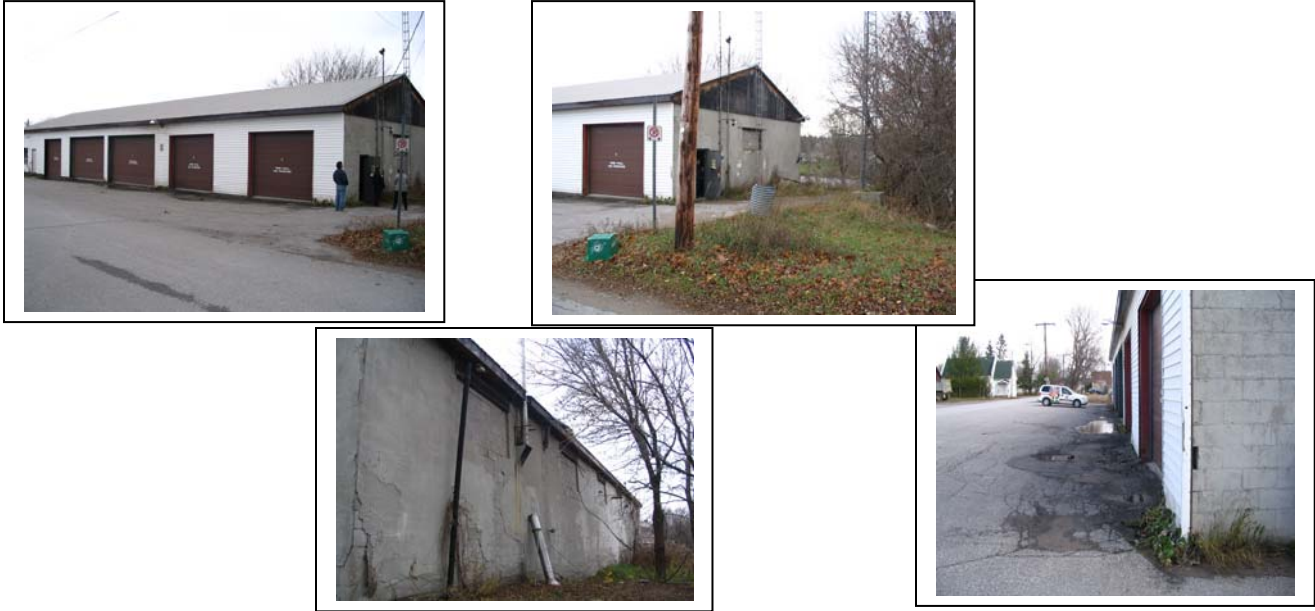
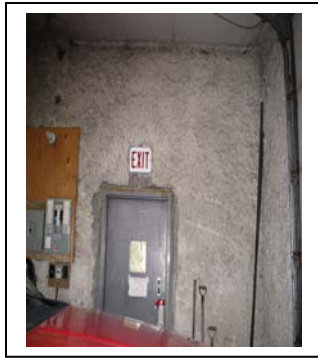
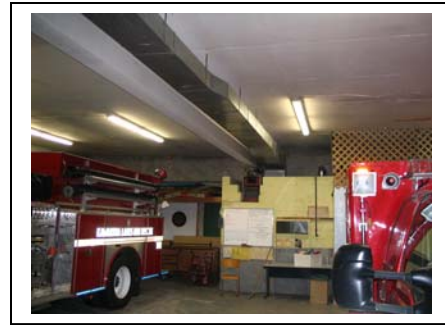
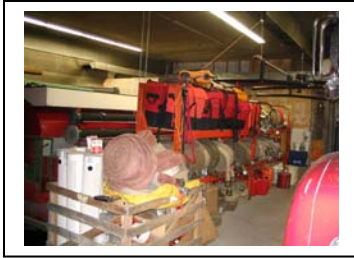
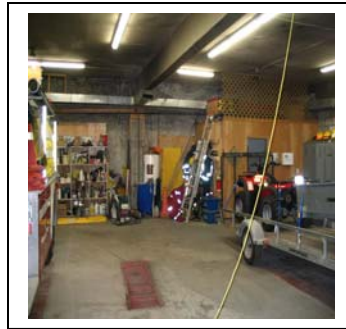
**Station 19: Coboconk – 47 Grandy Road**

**DESCRIPTION:** Station is poorly located and is built below existing roadway; poor entrance. It was not a purpose-built building, thus deficiencies exist. Originally a works department building.

Station is oil-heated by two furnaces at each end of the building; both need replacing. Asphalt in front of building needs replacing and extensive drainage and grading work is required. Roof needs work to prevent snow from falling off and blocking doors. Backyard needs fill and grading to increase parking area for firefighters; entrance from rear yard should be constructed.

That backyard be reworked to accommodate increased parking area for firefighters, and that an entrance from the rear yard be constructed.

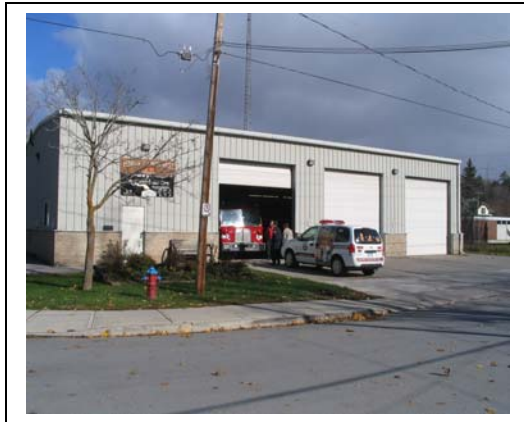
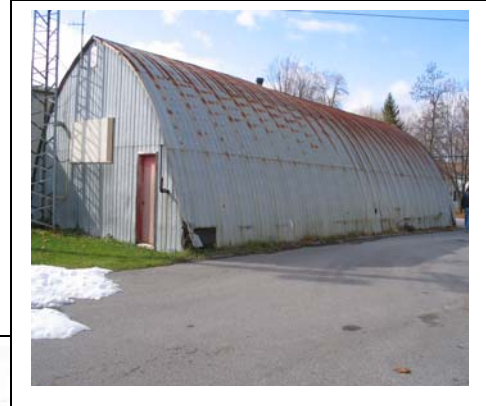
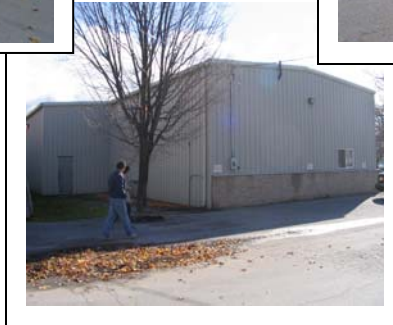
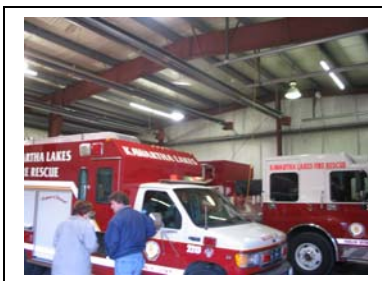
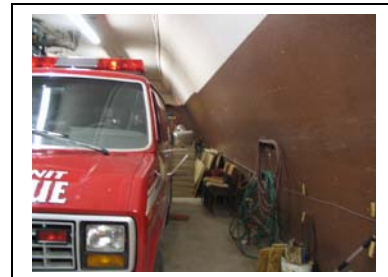
**Station 22: Fenelon Falls**

**DESCRIPTION:** Main hall was built in 1989 directly in front of Quonset hall (existing firehall). Quonset is now used for storage for extra apparatus. The station is located in a floodplain.

**RATING: B-C- D - roofing**

The main hall has leaking roof problem. The training room was never closed in from the apparatus floor and as such has dirt and dust problem. Inadequate washroom space to meet health and safety requirements. Quonset is kept as storage for extra apparatus floor space but has rusted out and leaks in several places. The foundation of Quonset hut is in questionable repair as water from melting snow at the arena runs in one side of the building and out the other side. There is not enough office space for the activity and increasing call volume. Hall assumes a major role in citywide training initiatives, however facilities need to be upsized and improved.
