Kawartha Lakes Road 24 Bridge Class Environmental Assessment

Public Information Centre #1

April 16th, 2008

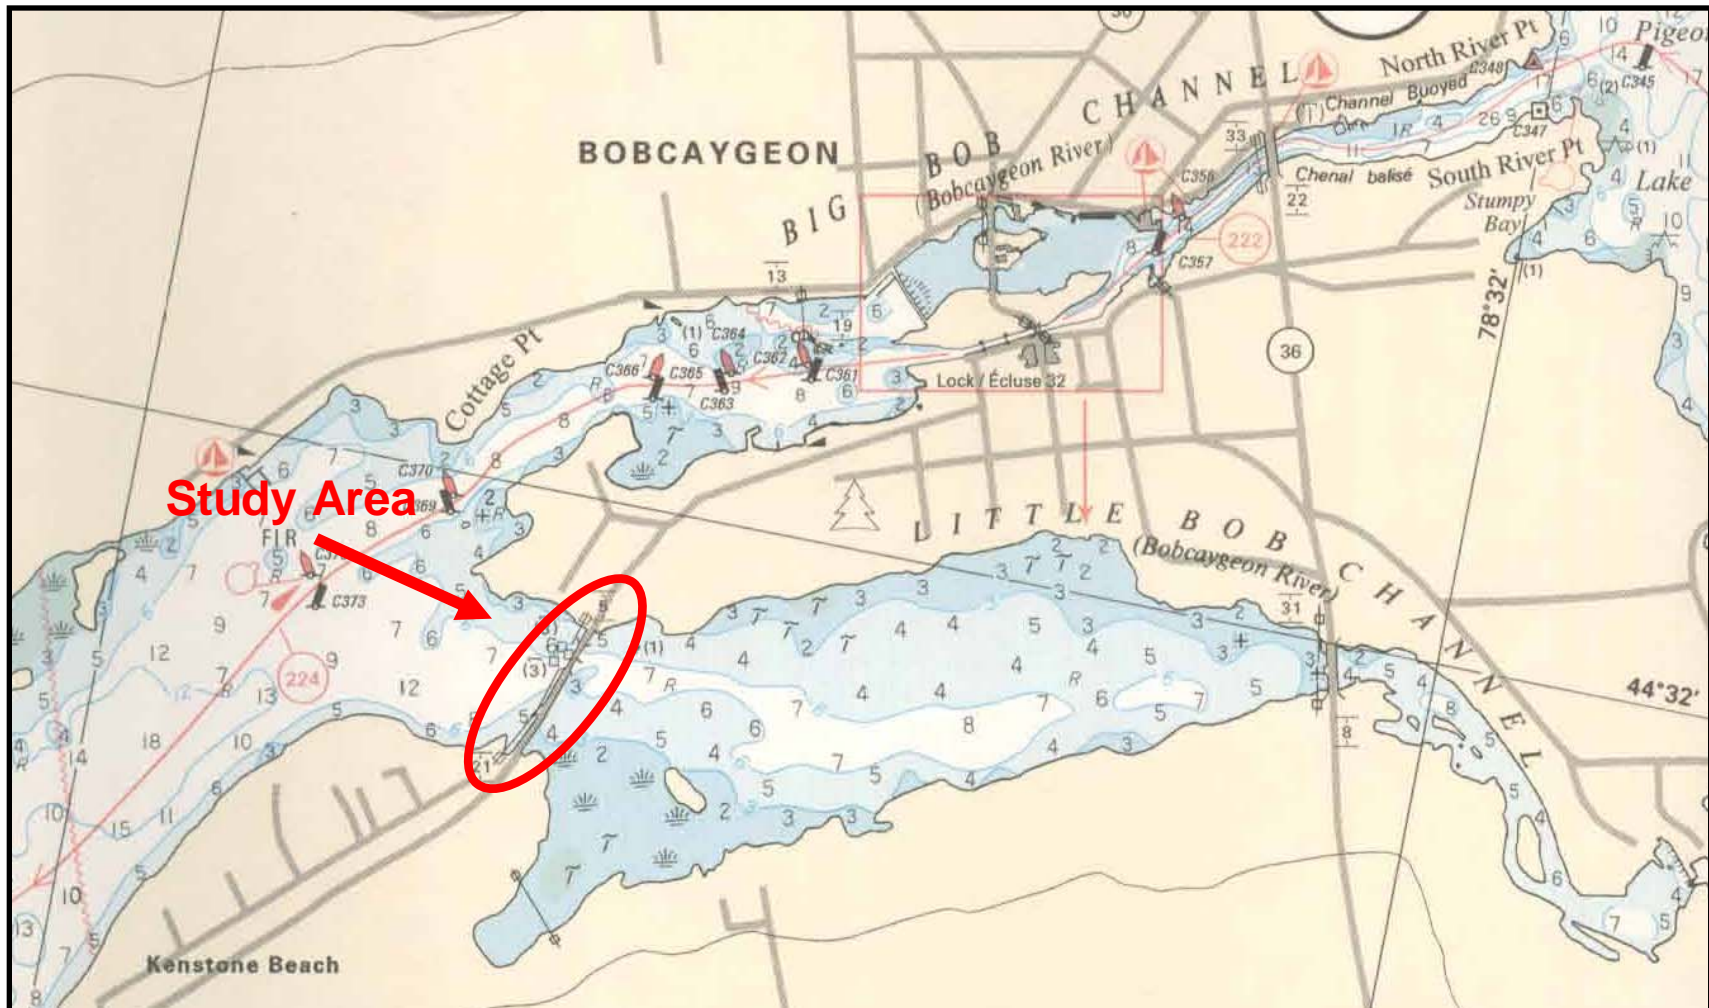
Depths of Little Bob Channel/Sturgeon Lake

Source: Surveyed by the Canadian Hydrographic Service, 1965, 1966, 2001 and 2005. Trent-Severn Waterway Chart 2025, portion of Sheet 1 of 3

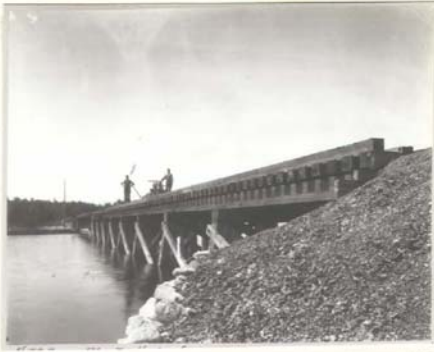
Category 21.21.07 Photograph A-21835
Subject Canadian Pacific Ry pile-trestle and swing-span over the Little Bob River, 1/2 mile south of Bobcaygeon, Ont., viewed from the north-east. Mile 38.2 Bobcaygeon Subdivision. (Length 483', height 15'6')

- Original structure built in 1904 as a railway swing bridge
- Track was abandoned in 1961 by CPR
- Converted to a single lane road bridge in 1963 when acquired by Verulam Township
- Bridge was widened to two lanes in 1973
- Swing bridge section is not operable however mechanism is still in place
- The first train arrived in Bobcaygeon on July 28, 1904

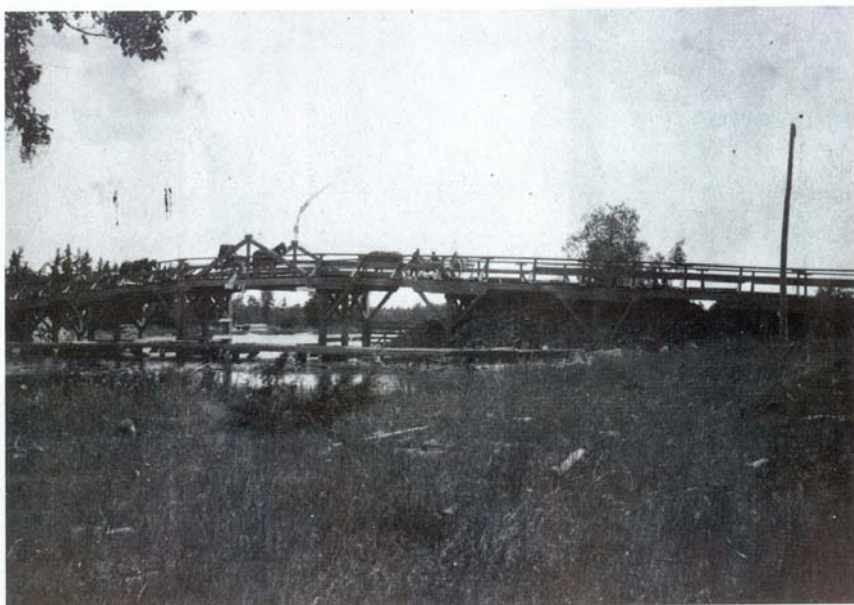
This was the first bridge over the Little Bob River, on Highway 36. Notice how this bridge was built on a bill so that it was high enough for boats with lumber or logs to pass under on their way to the sawmill by the Little Bob

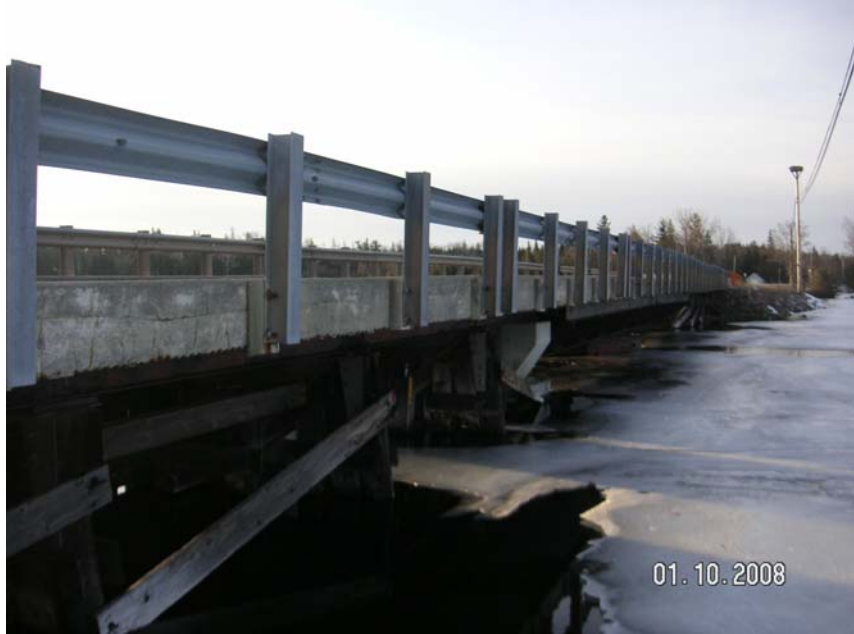
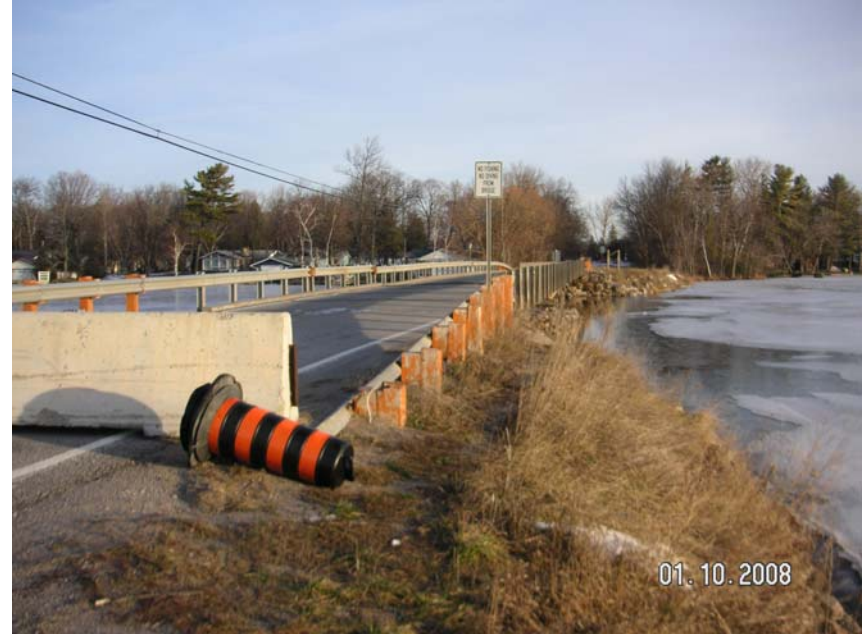
City of Kawartha Lakes Road 24 Bridge (#24112)

- Constructed in 1904 over the Little Bob Channel of Lake Sturgeon
- Ten span, structural steel girder and timber girder bridge with a concrete deck and an asphalt wearing surface
- Bridge deck accommodates two traffic lanes and no sidewalks
- The bridge is currently closed - does not meet the requirements of the bridge code and rehabilitation required is extensive
- Bridge is one of four accesses to the Village of Bobcaygeon
