# MASTER FIRE PLAN TASK FORCE

## STATION LOCATION SUBGROUP REPORT

**Date:** December 2008  
**Subject:** Fire Station Locations  
**Subgroup Name:** Station Location Subgroup

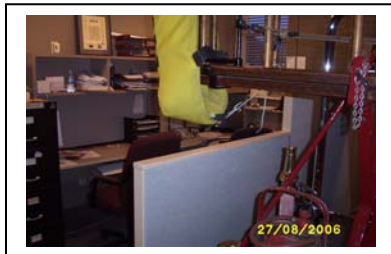
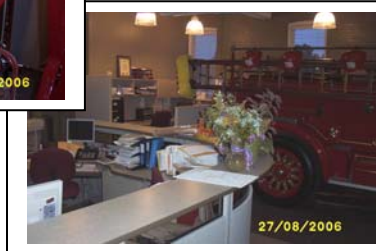
Too small for the number of administration offices in a combined response station.

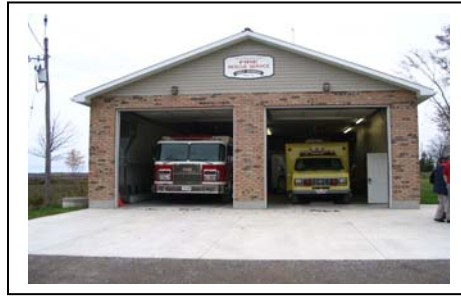
**Station 6: Emily - Omemee**

**DESCRIPTION:** Fire hall accommodates one truck and one ambulance; has plenty of room to accommodate future expansion.

**RATING: A**

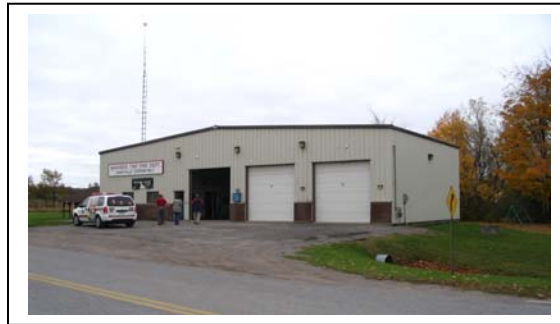
**Station 9: Janetville -**

**DESCRIPTION:** Fire hall is of good design and in a good location.

**RATING:** A

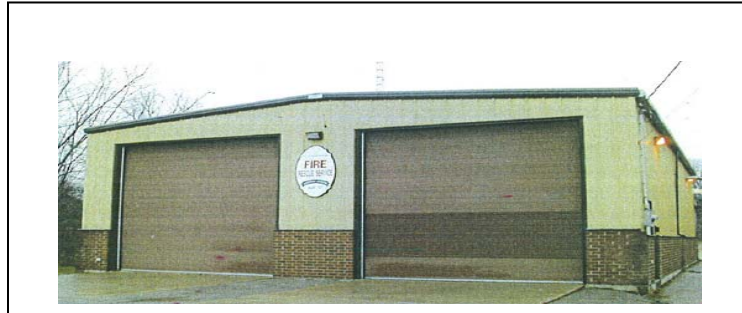
**Station 12: Cameron**

**DESCRIPTION:** This station was established as a substation for Fenelon Falls.

**RATING: C D - Water**

That issues related to water access be further investigated.

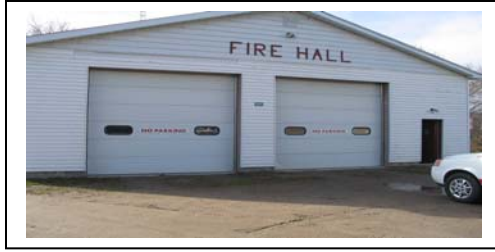
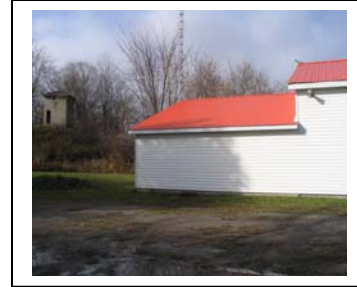
**Station 17: Norland -**

**DESCRIPTION:** This hall was originally designed as a two-bay station but currently houses three vehicles.

**RATING: B**

The issue of entrance safe access/egress from station needs to be further investigated.

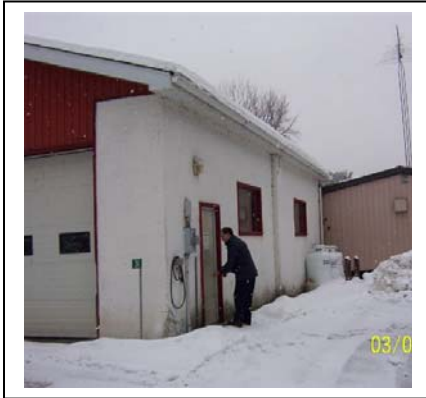
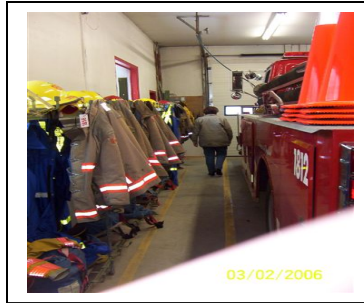
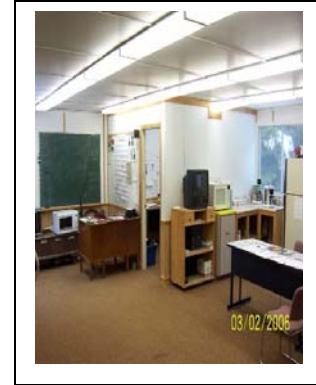
**Station 18: Kinmount – 24 Majestic Street**

**DESCRIPTION:** Station is in poor location and experiences low call volume.

**RATING: D-C**

That backyard be reworked to accommodate increased parking area for firefighters, and that an entrance from the rear yard be constructed.

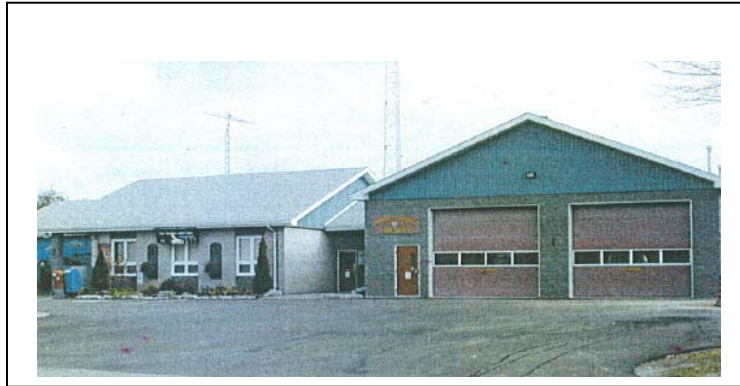
**Station 20: Burnt River – 186 Burnt River Road**

**DESCRIPTION:** Well-maintained building.

**RATING:** A

**RECOMMENDATIONS:** That maintenance and upkeep be maintained.

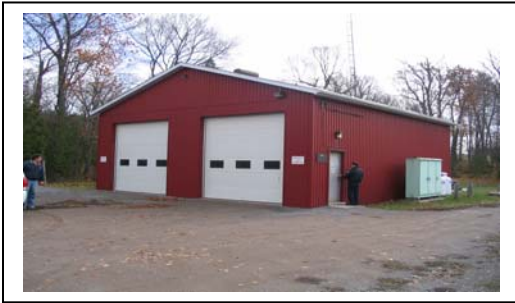
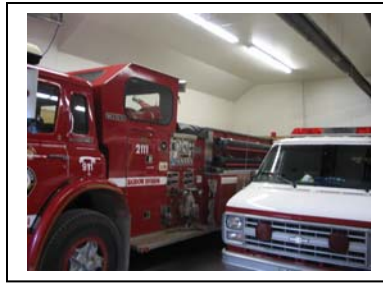
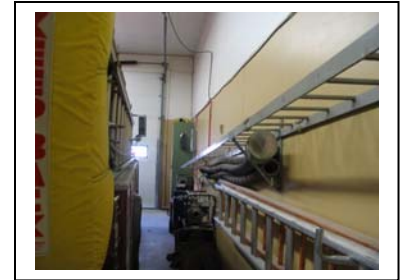
**Station 21: Baddow – Lot 12**

**DESCRIPTION:** Very small station; low call volume.

**RATING: C**
